Contract #: 04-0120F4Cty: SF/ALA Rte: 80 PM: 13.2/13.9File #: 69.28**WELDING INSPECTION REPORT****Resident Engineer:**Pursell, Gary**Address:** 333 Burma Road**City:** Oakland, CA 94607**Report No:** WIR-002832**Date Inspected:** 08-Jun-2008**Project Name:** SAS Superstructure**OSM Arrival Time:** 1400**Prime Contractor:** American Bridge/Fluor Enterprises, a JV**OSM Departure Time:** 300**Contractor:** Zhenhua Port Machinery Company, Ltd (ZPMC), Changxing Island **Location:** Shanghai, China

Bridge No: 34-0006**Component:** OBG side, bottom and deck panels**Summary of Items Observed:**

WELDING INSPECTION REPORT

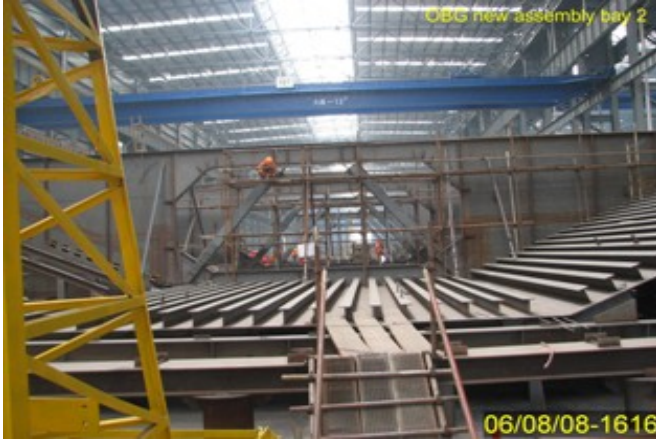
QA observed ZPMC qualified welding personnel performed the Gas Metal Arc Weld (GMAW) and Submerged Arc Weld (SAW) 3 Rib PMT# 1 for deck panels DP-601-00 and DP-551-00 on gantry #1. ZPMC welding personnel commenced welding PMT #1 for gantry #1 at 0021 hrs for the above mentioned deck panels. QC and QA visually inspected and accepted 500mm segments of each weld on this PMT panel. ZPMC's QC Ultrasonic Testing (UT) technician ultrasonically inspected and accepted the same 500mm segments of each weld based on the depth of penetration acceptance criteria for closed Rib to deck plate Partial Joint Penetration (PJP) welds specified in the contract documents. Caltrans waived the UT for this PMT today. QA laid-out, match marked and stenciled 5 macro specimens on each PMT rib. QA completed a U-Ribs PMT inspection report for this date and gantry. The report is on file in the Caltrans QA office. The welding parameters and welder ID's for Gantry 1 PMT #1 are as follows:
